**Subject: Field Oversight Summary No. 2
Final Remedial Design Activities
Blackwell Forest Preserve Landfill, DuPage County, Illinois
Contract No. 68-W8-0084, Work Assignment No. 84-5P6Y**

**FIELD OVERSIGHT SUMMARY NO. 2
FINAL REMEDIAL DESIGN ACTIVITIES
BLACKWELL FOREST PRESERVE LANDFILL
DUPAGE COUNTY, ILLINOIS**

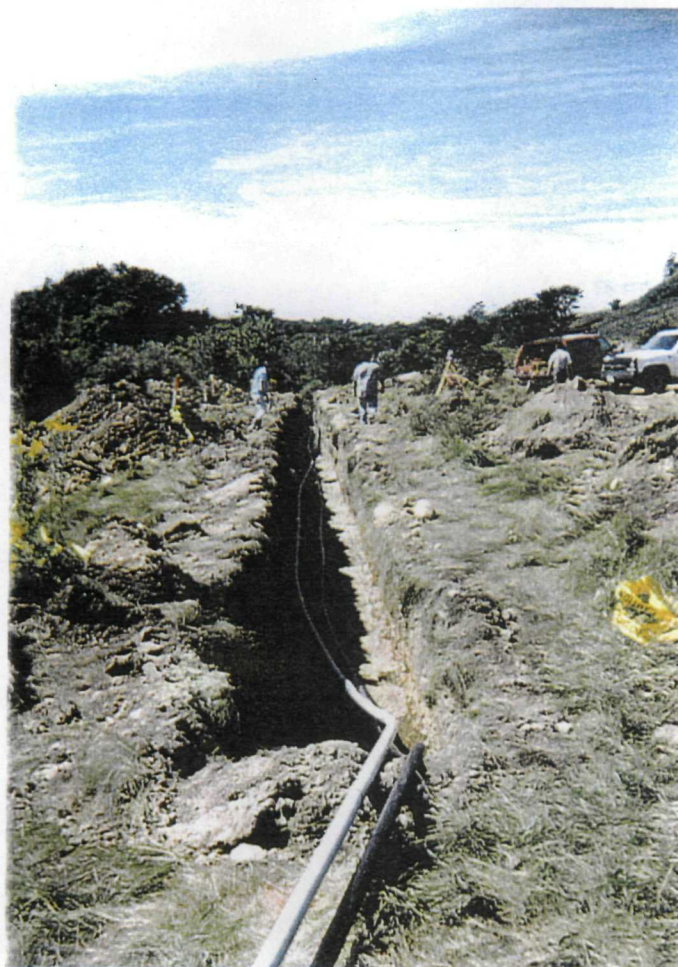
Photograph No. 1

Description: Leachate collection system (LCS) trench between extraction well EW-08 and drip leg DL-01; bottom sand layer (about 10 inches thick) and LCS piping had been placed in trench

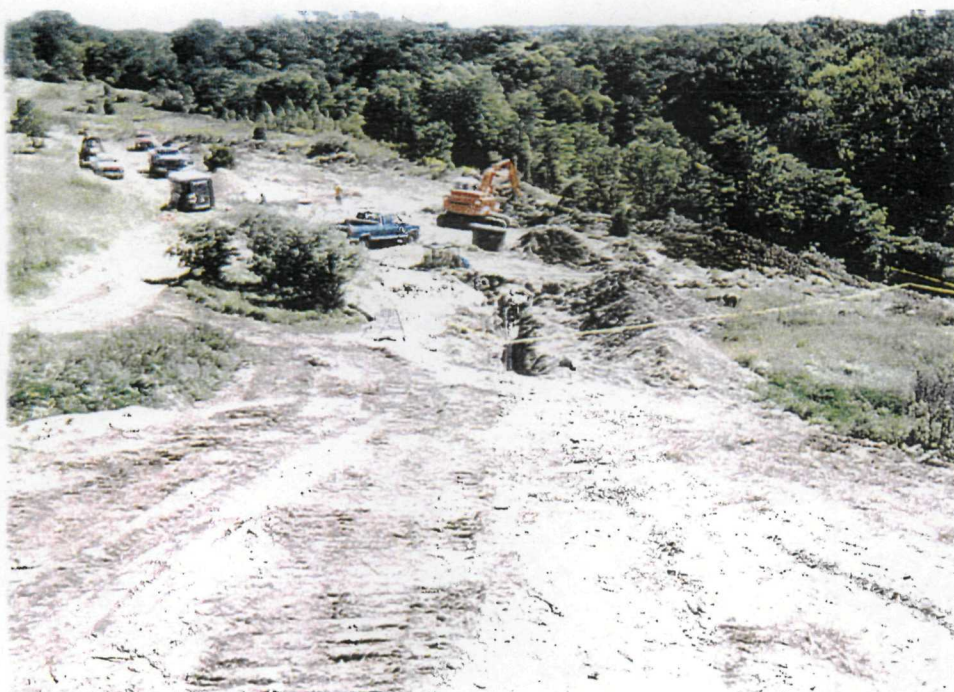
Photograph No. 5

Description: LCS trench between EW-05 and EW-06 (center); trench had been backfilled with compacted clay to within about 30 feet of EW-06 excavation

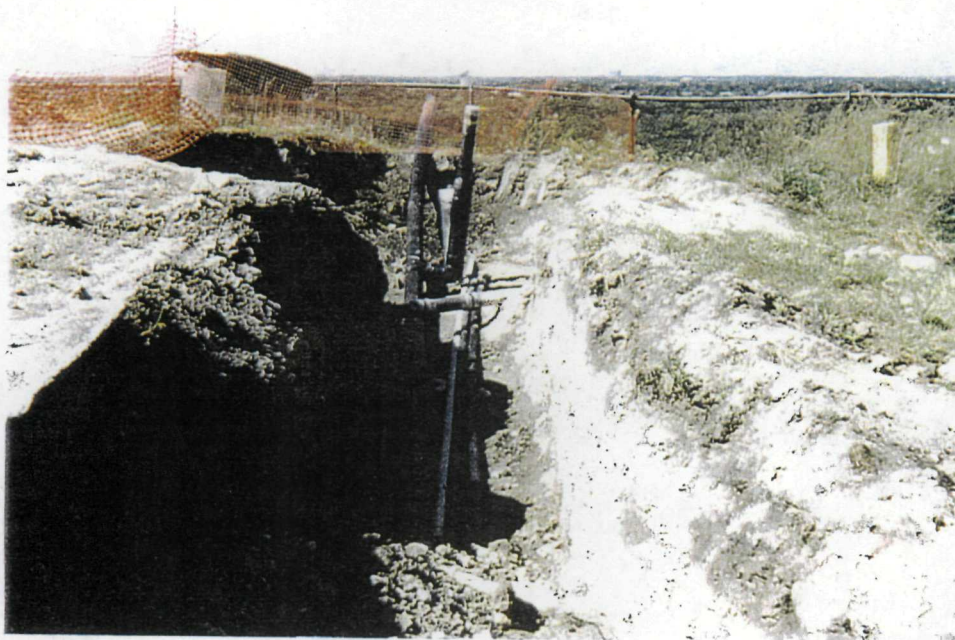
Photograph No. 9

Description: LCS trench near EW-04 excavation; trench had been backfilled to within 20 feet of EW-04; pipe crossing trench was for gas conveyance from gas well to the right (yellow casing) to flare that used to be on top of landfill

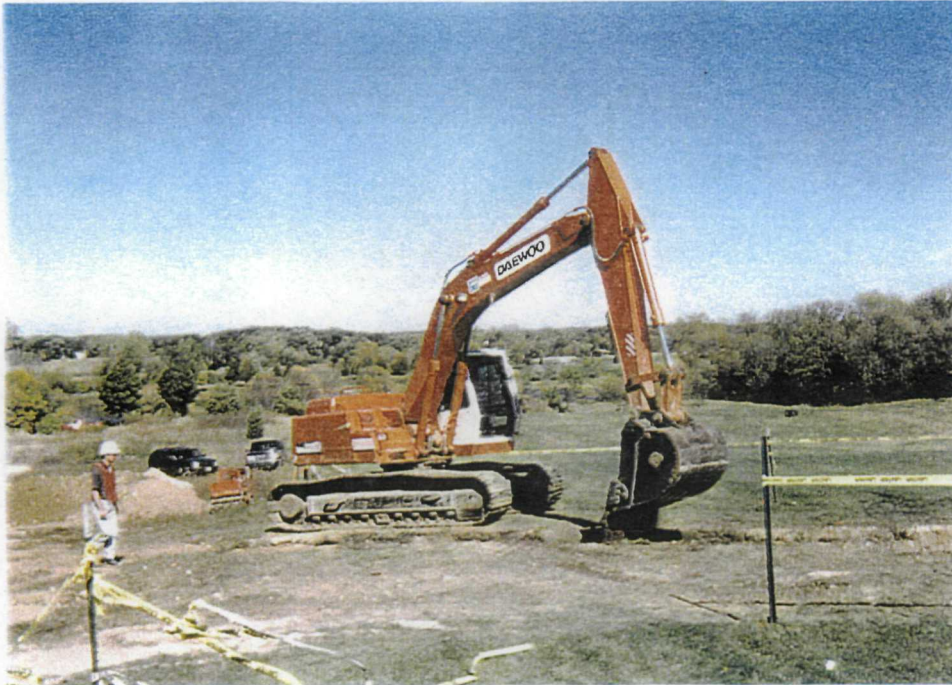
Photograph No. 13

Description: Backfilling of LCS trench between EW-03 and EW-01A with native material previously excavated from the trench

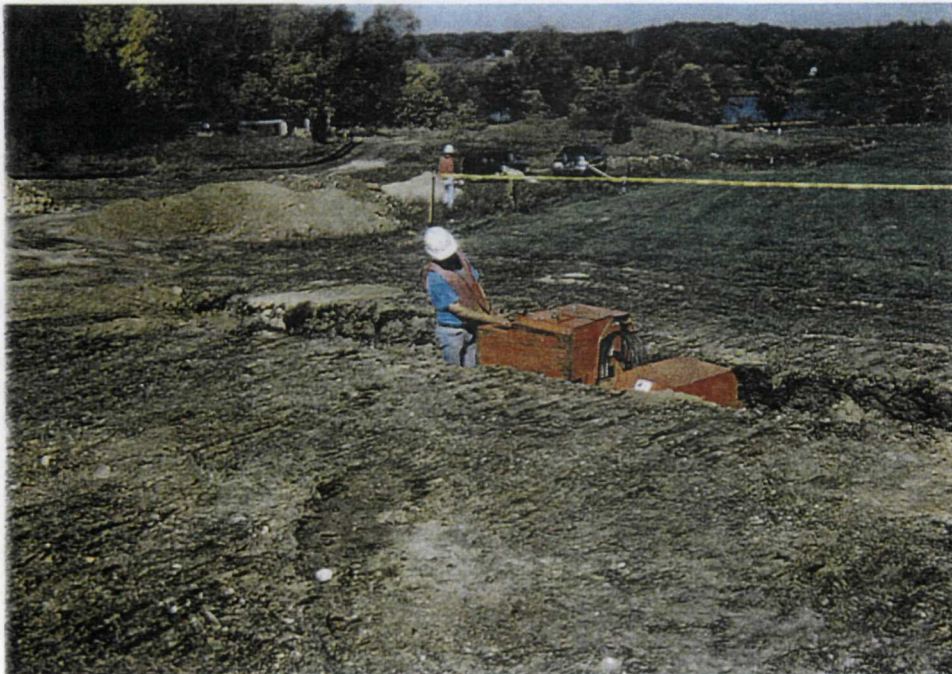
Photograph No. 14

Description: RTE compacting clay in LCS trench between EW-03 and EW-01A

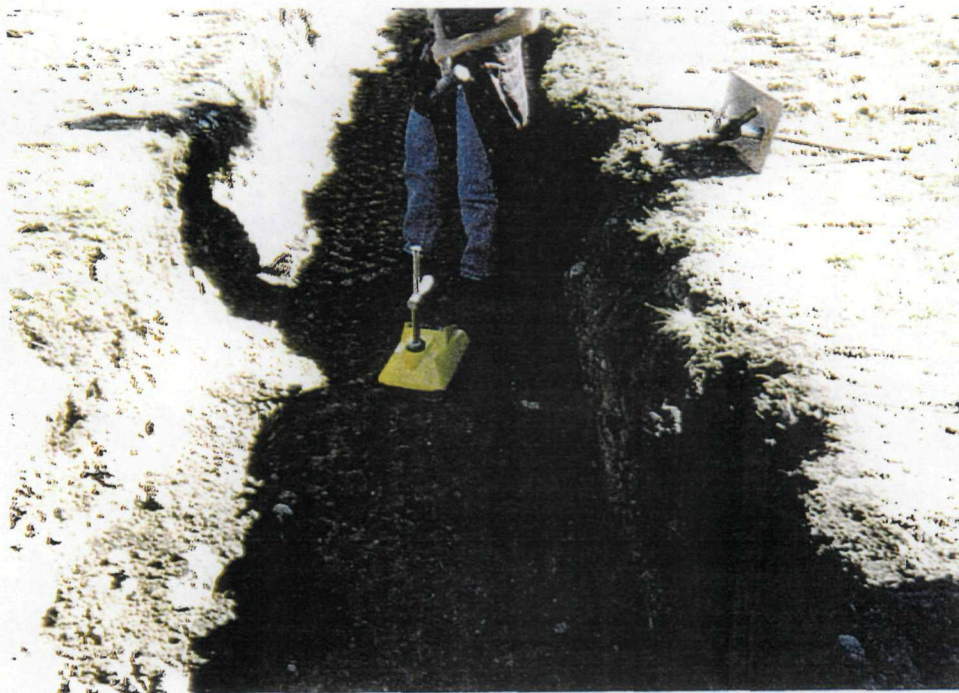
Photograph No. 15

Description: Testing Service Corporation (TSC) personnel performing compaction test on backfilled clay in trench between EW-03 and EW-01A

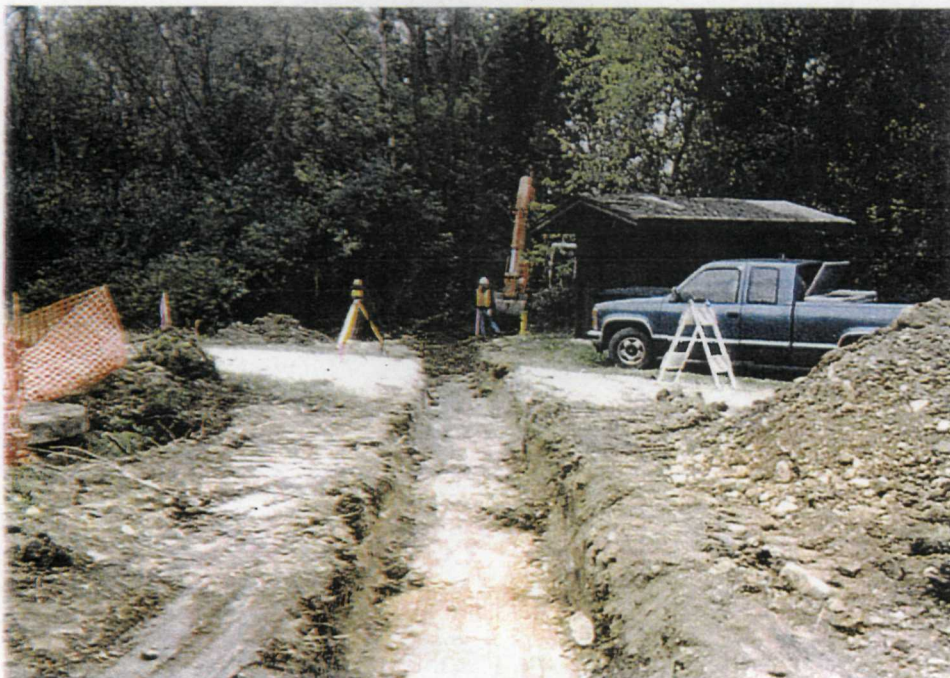
Photograph No. 18

Description: RTE excavating LCS trench on north side of landfill near MH-2 (inside orange fencing on left); note that trench was shallow in this area; therefore, ground surface had to be built up in order to provide enough cover for frost protection

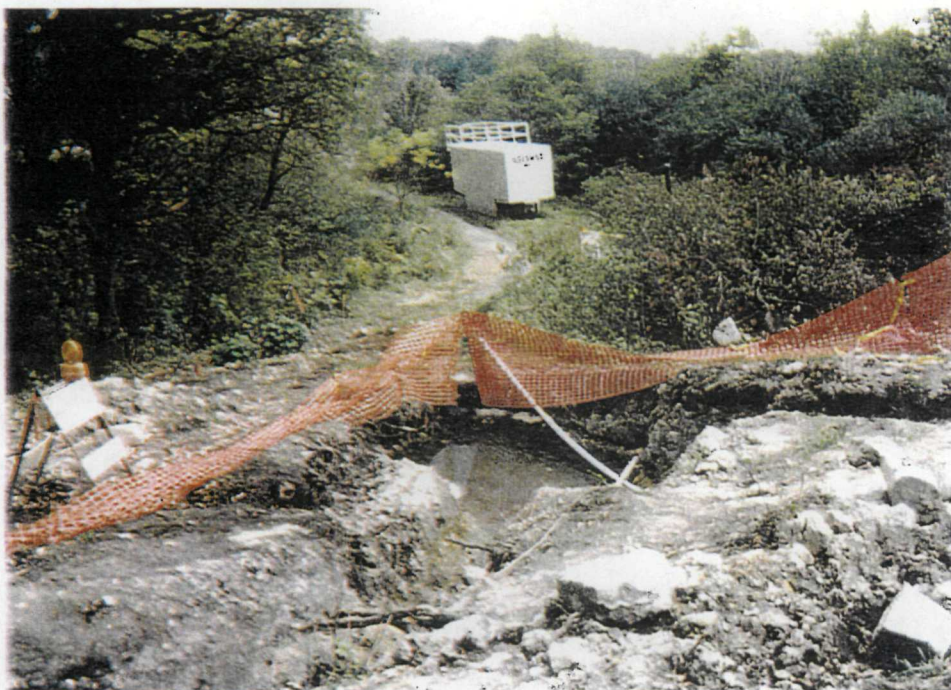
Photograph No. 23

Description: DL-01 excavation with water still present; holding tank in background to be used to contain water pumped from excavation

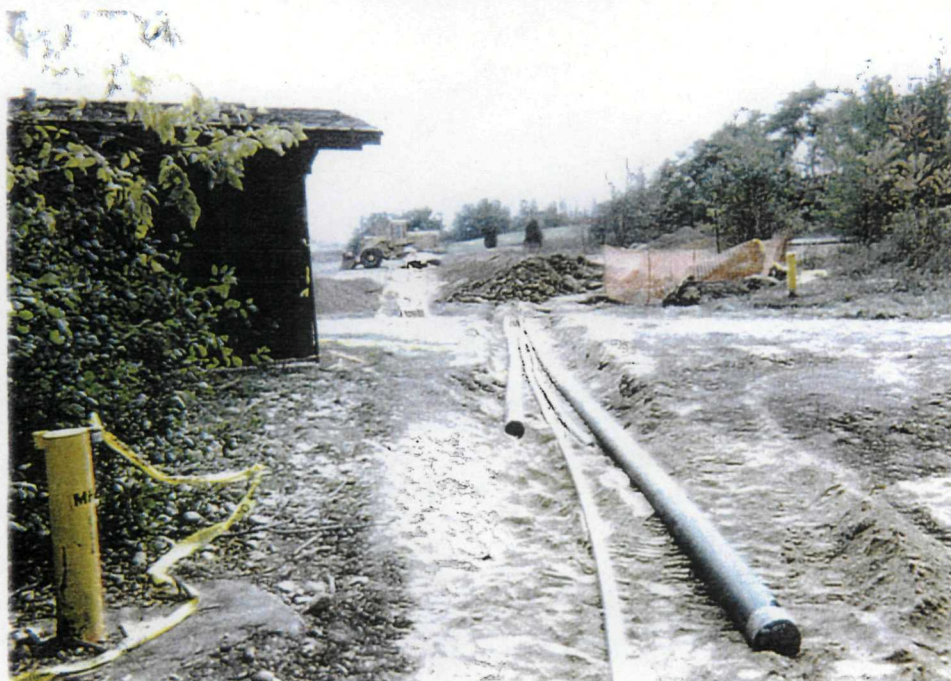
Photograph No. 3

Description: LCS trench where it entered wooded area on north side of landfill; MH-2 (yellow) to left; ground surface over trench in background had built up in order to provide sufficient cover for frost protection

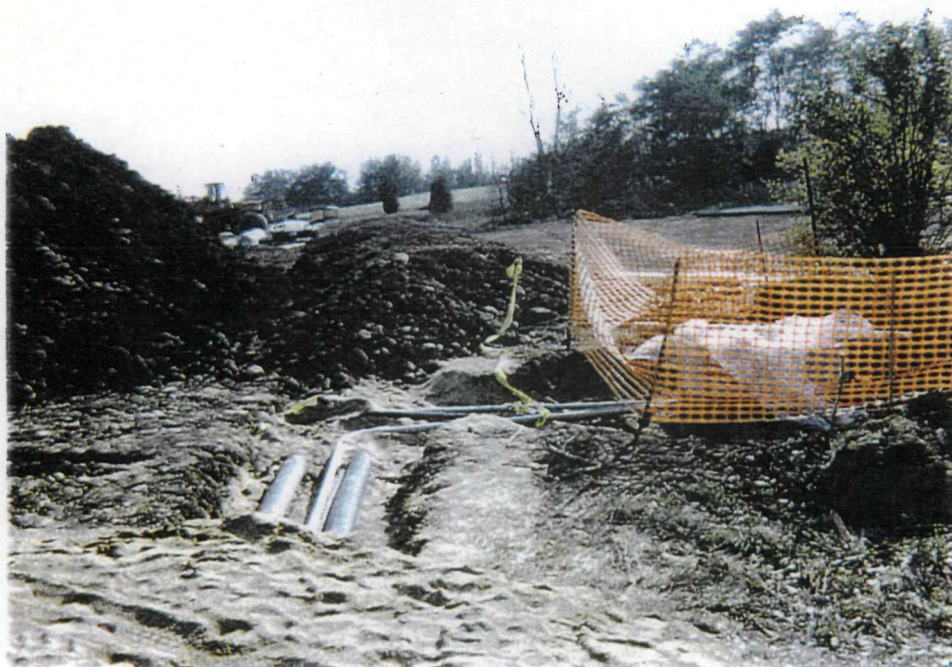
Photograph No. 9

Description: LCS trench up to point where it entered wooded area; ground surface had been built up to provide sufficient frost protection; connections to MH-3 (orange fence) had also been made

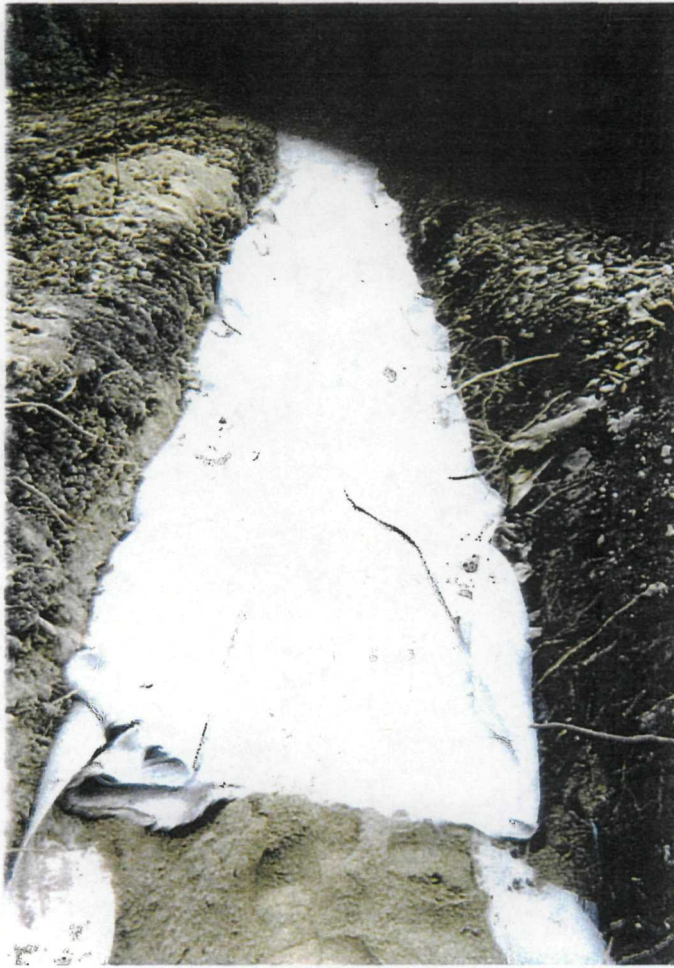
Photograph No. 15

Description: Close-up of LCS trench and GCL after trench had been backfilled with sand, sides of GCL had been folded over, and additional layer of GCL had been placed on top

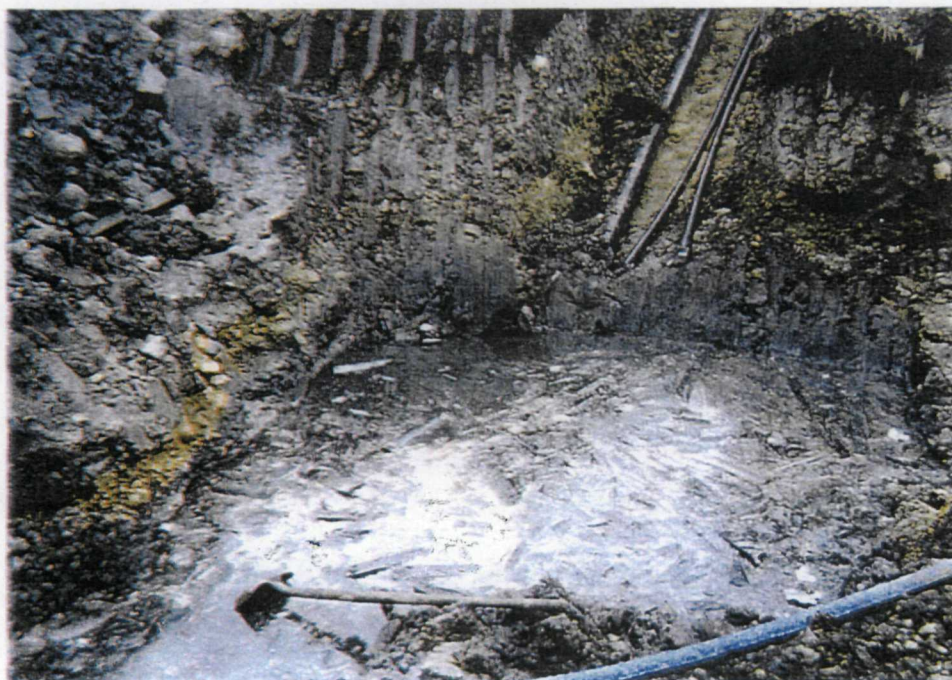
Photograph No. 23

Description: Close-up of water in DL-01 excavation; sheen noted on water surface; waste floating in water consisted mainly of wood

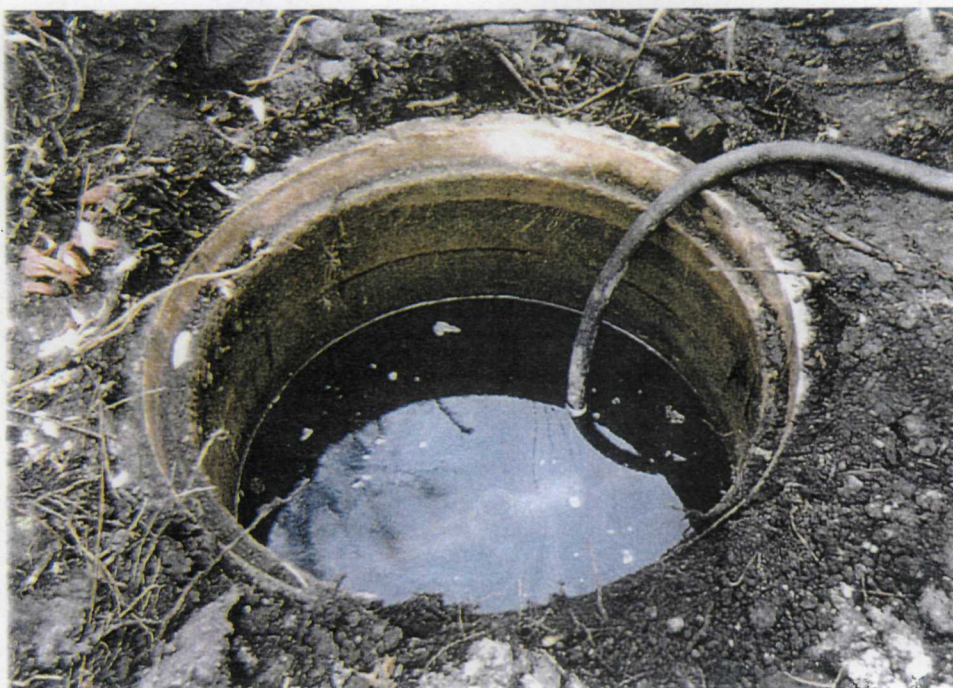
Photograph No. 24

Description: View of water in MH-20 near DL-01 excavation; a plug had been placed in white pipe in MH-20 to cutoff water flowing into it

Montgomery Watson suspects
that the source of the water
is MH-20. They plan to
plug this well temporarily
while they pump out the
DL-01 excavation. Then
when the drip leg is installed,
they will replace the plug
at MH-20 & allow it to
flow to the drip leg.

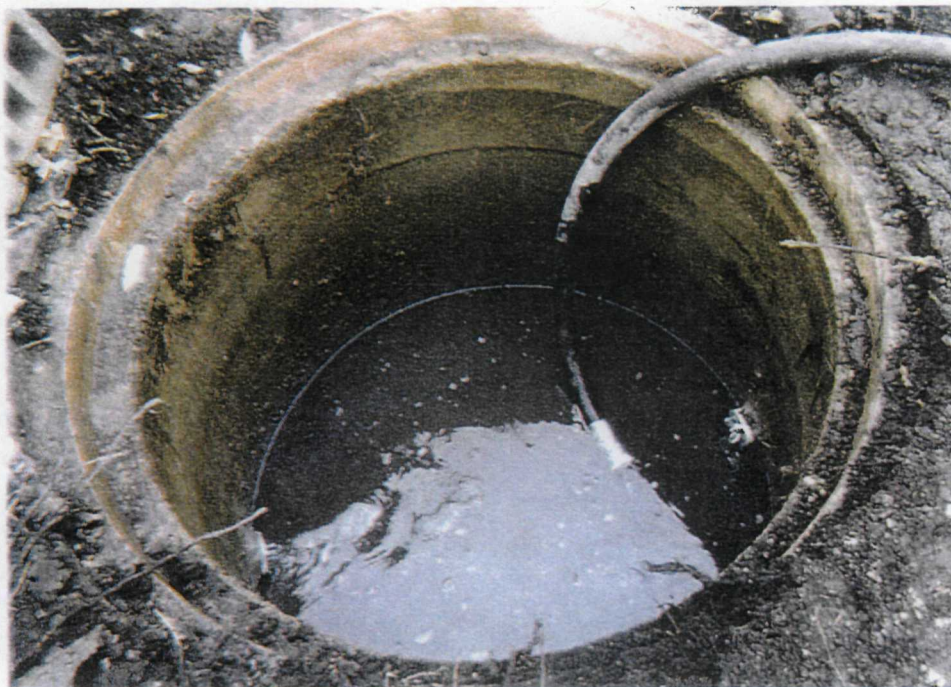
Photograph No. 26

Description: MH-20 after most of the water in it had been pumped out; white pipe in MH-20 had been cut and removed; ends of pipe had been plugged; however, pipe to left was leaking around outside of pipe

Photo 26 (S) - MH 20 after it
has been pumped out. The
leachate pipe in it has been
cut & removed & the ends
capped. The area around
the pipe to the left is
leaking around the outside
of the pipe & filling up the
manhole. This manhole
will be pumped out again
before it is connected to
the lift station

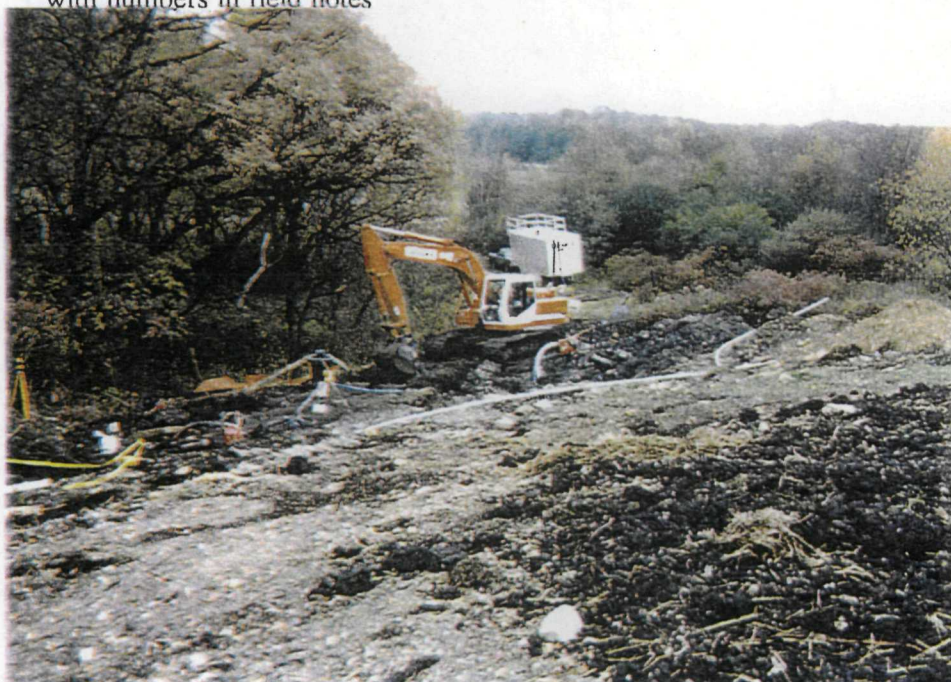
Photograph No. 2

Description: Overview of DL-01 excavation activities; waste removed from excavation on right; pump and white hose used to remove water from excavation in front of excavator; lift station (black pipe) on left
